Operating Experience Weekly Summary 97-50

December 5 through December 11, 1997

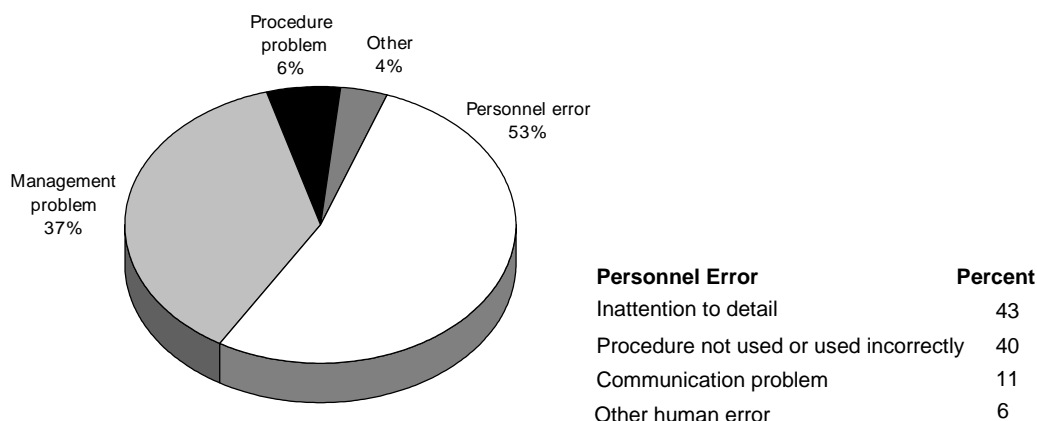
Figure 3-1. Root Causes for Failure to Follow Procedures (Glovebox Events)¹

OEAF engineers searched the ORPS database for glovebox events involving procedures not used or used incorrectly and found 216 occurrences. Figure 3-1 shows the root causes for these events. A review of these occurrences shows that that facility managers reported 53 percent of the events as personnel errors, with 43 percent attributed to inattention to detail. In addition, managers reported 37 percent as a management problem, with 48 percent attributed to inadequate administrative control.

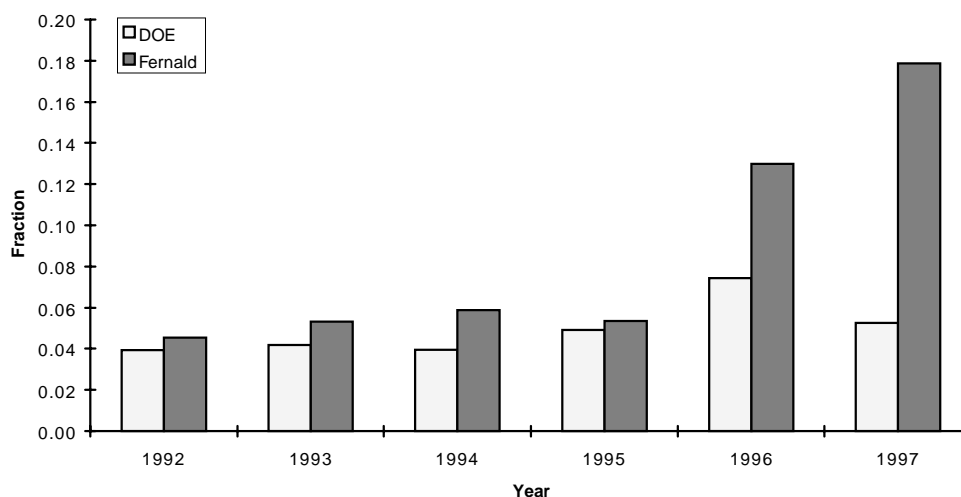
Figure 6-1. Fraction of Occurrences Attributed to "Communication Problem" at Fernald and DOE-Wide¹

OEAF engineers searched the ORPS database for events at Fernald and DOE-wide with either a direct, contributing, or root cause attributed to "communication problem." Figure 6-1 shows the data from 1992 to the present at Fernald and DOE-wide. The data was normalized by showing occurrences with a cause of communication problem as a fraction of all occurrences per year. OEAF engineers performed a statistical test to determine the significance of the increase in the fraction of occurrences attributed to communications problems in 1996 and 1997 compared to 1992 to 1995. They found there was a 95 percent probability that the fraction had increased by at least 75 percent.
